CSP FY01 Milestone Report

“Identify reasons for failure of thin glass mirrors and recommend solutions to industry to avoid further problems in the field”

02/28/01

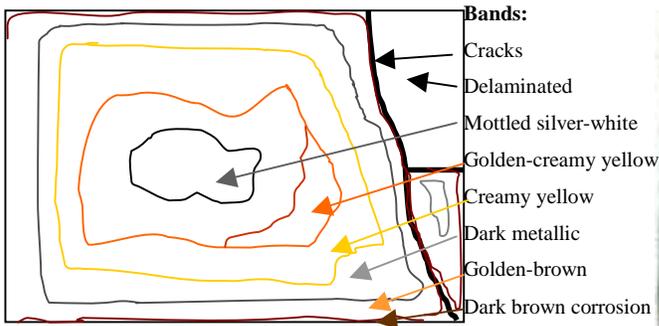
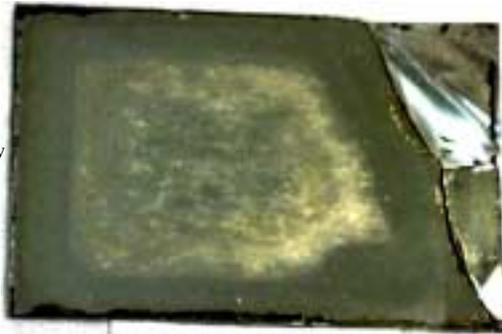
The matrix of small samples subjected to AET is provided in [1]; glass mirror thicknesses of 0.7, 1.0, and 2.4 mm were tested in combination with a variety of adhesives. In general, all small glass mirrors display signs of degradation regardless of adhesive and glass type. This is true for samples of thin glass (≤ 1.0 mm) provided by other (non-U.S.) companies (such as Steinmüller and Schlaich, Bergermann und Partner in Germany). The performance of the thin glass mirrors degrades quicker than the thicker (2.4-mm) glass mirrors tested. None of the edge seals tried have worked; they discolor or become porous and crack (especially among the epoxies). All samples exhibited mirror discoloration, corrosion, and loss of specular reflectance similar to that experienced in the field.

Figure 2. Line drawing of corrosion bands for small sample R1558-49-2 after 25 Mo. Total AET = 18 months in XENO + 7 months in WOM

Figure3. Digital photograph of corrosion bands for small sample R1558-49-2 after 25 Mo. Total AET = 18 months in XENO + 7 months in WOM

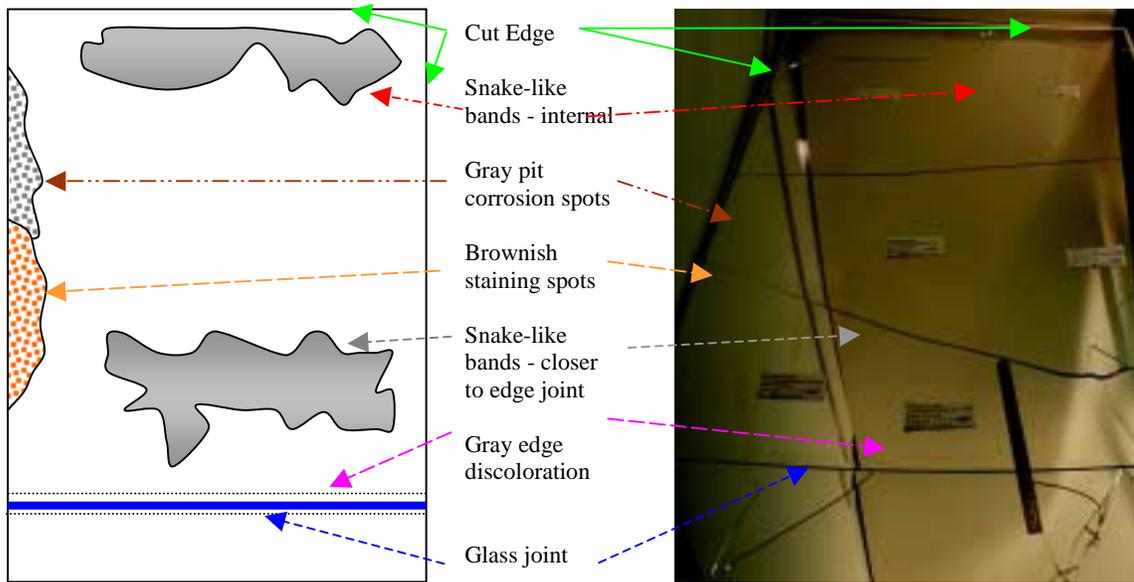
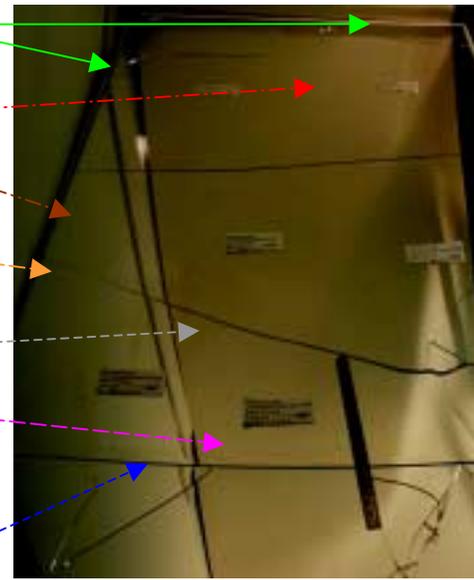
This 0.8 x 0.6-m facet section was an excellent representative of the corrosion on the facet because it had all of the forms of “mirror graying” observed on mirror facet elements and the corrosion was dark enough to photograph. These visual imperfections include snake-like bands of discoloration over large areas internal to the mirror, brownish

staining at the edge, pit corrosion, and corrosion along crack lines. This section has a glass joint 0.1-m from the edge as shown in Figures 4 and 5. Gray edge discoloration (about 10-12 mm wide) is parallel to the joint on both sides of the glass joint. This corrosion band is slightly darker than the glass and is very difficult to observe unless viewed at an angle under a strong light. There is an area 110-mm wide by 450-mm long of golden-brown to gray spots approximately 1 to 10-mm in diameter along the cut-edge perpendicular to the joint. The brownish staining spots begin approximately 120 mm from the joint and are about 150 to 200-mm long. The gray pit corrosion spots begin approximately 450-mm away from the joint. The snake-like bands of discoloration cover large areas internal to the mirrors (i.e., away from the edges) and are gray. A large area of snake-like bands is approximately 150 to 180-mm from the glass joint and 150-mm from the adjacent cut-edge and about 150-mm wide. Another band is approximately 20 to 40-mm from the cut-edges, about 200-mm wide and is almost as long as the width of the section cut from the facet. Very little modification of the digital image was needed to view the corrosion spots in the photograph.

Figure 4. Line drawing of “mirror graying” for facet section C2554-27-5 after 21 Mo. of exposure in Arizona

Figure 5. Digital photograph of “mirror graying” for facet section C2554-27-5 after 21 Mo. of exposure in Arizona

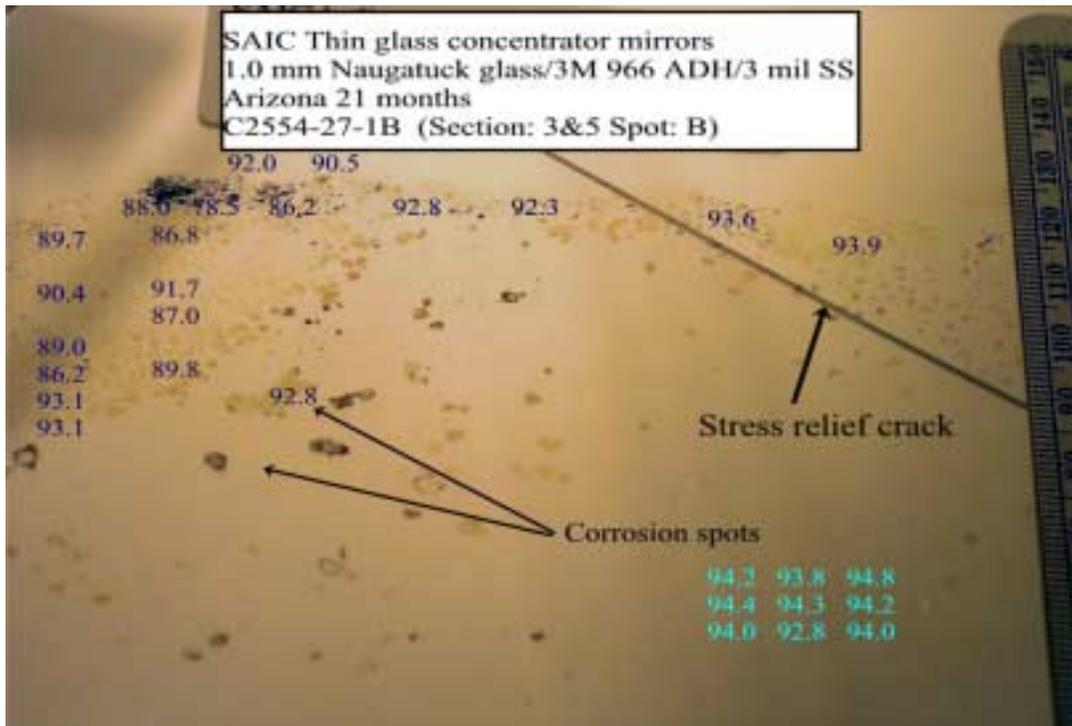
C2554-27-1B; Corrosion spots

Golden-brown to dark-gray spots approximately 1 to 10-mm in diameter in an area 152-mm wide by 152-mm long adjacent to a cut-edge in facet section C2554-27-1 are shown in Figure 6. The dark gray pit corrosion spots are mixed with the brownish staining spots. Very little modification of the digital image was needed to view the corrosion spots in the photograph. The specular reflectance values measured at the corrosion spots is in dark blue on the photograph with an average specular reflectance of 89.7%. The specular reflectance of the uncorroded area is in light blue with an average specular reflectance of 94.1%. This is a loss in specular reflectance of 4.3%.

Figure 6. Digital photograph and specular reflectance of brownish staining and dark gray pit corrosion spots for facet section C2554-27-1 after 21 Mo. of exposure in Arizona.

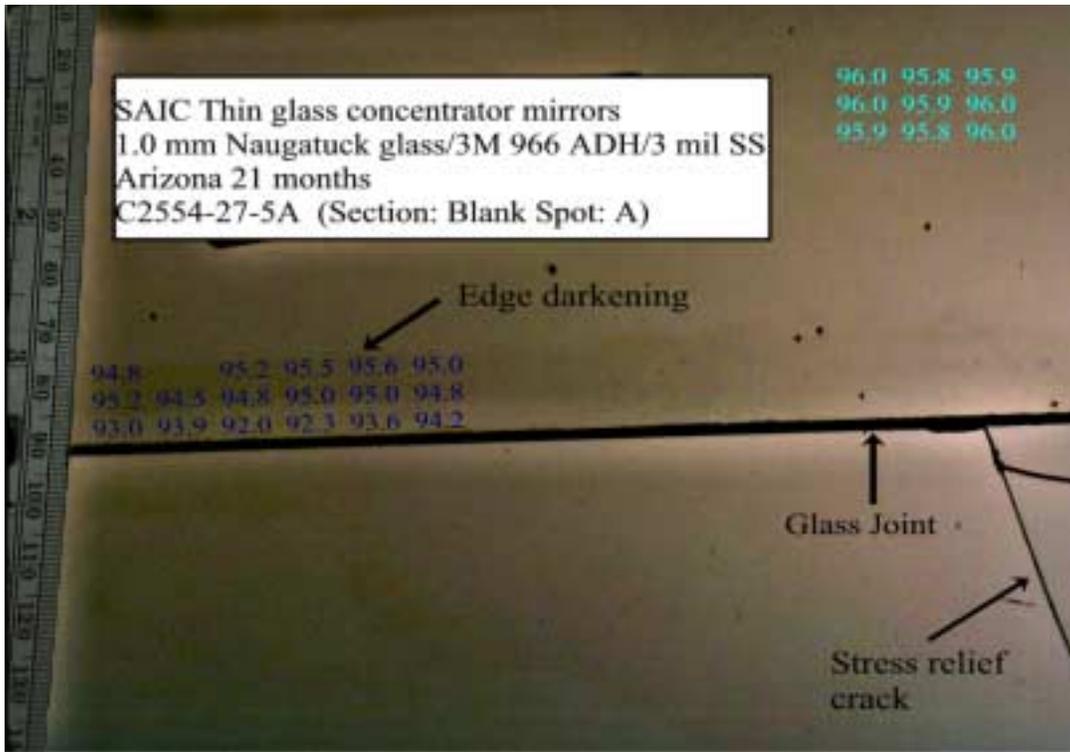
C2554-27-5A; Edge corrosion band

The glass joint and edge corrosion band in facet section C2554-27-5 are shown in Figure 7. The gray edge discoloration (about 10-12 mm wide) is parallel to the joint on both sides of the glass joint. This corrosion band is slightly darker than the glass and is very difficult to observe unless viewed at an angle under a strong light. Significant modification of the digital image was needed to view the corrosion band in the photograph. The specular reflectance of the corrosion spots is in dark blue on the photograph with an average specular reflectance of 94.4%. The specular reflectance of the uncorroded area is in light blue with an average specular reflectance of 95.9%. This is a loss in specular reflectance of 1.5%. However, because of the large beam size inherent to the D&S specular reflectometer, the specular reflectance of the corrosion band may be elevated by sampling/measuring areas that may have included non-corroded regions.

* The specular reflectance of the edge corrosion band may be high because uncorroded areas may have been included in the measurements because the edge corrosion band is so narrow.

Figure 7. Digital photograph and specular reflectance of band of edge darkening at glass joint for facet section C2554-27-5 after 21 Mo. of exposure in Arizona.

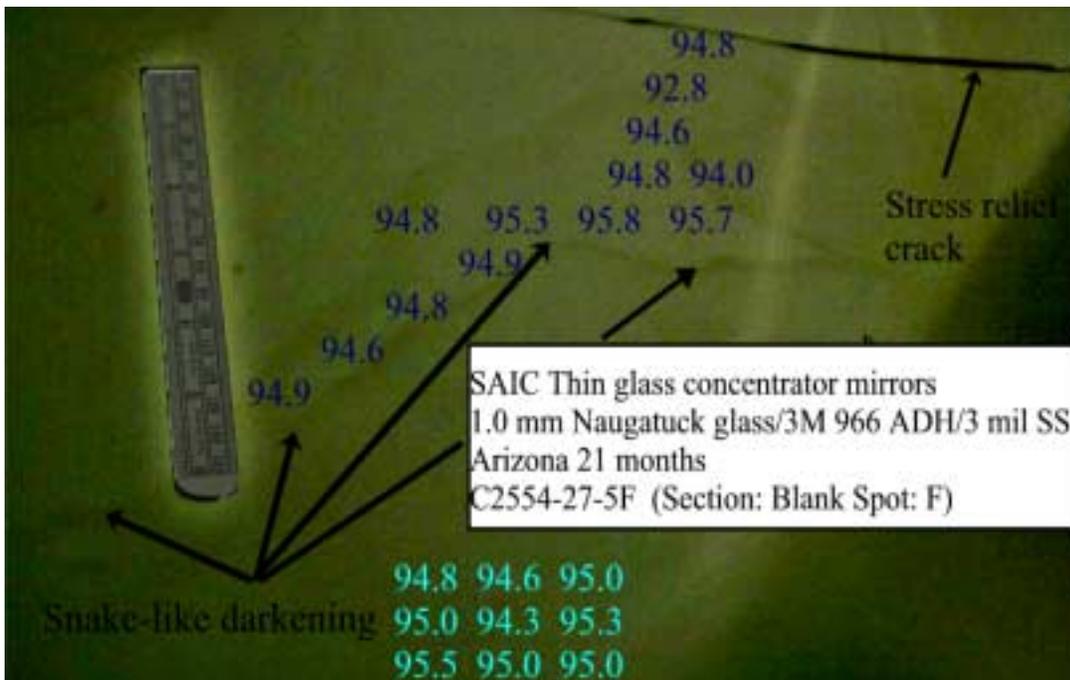
C2554-27-5F; Snake-like corrosion band closer to edge joint

An area of a snake-like corrosion band that is approximately 150 to 180-mm from the glass joint and 150-mm from the adjacent cut-edge and about 150-mm wide in facet section C2554-27-5 is shown in Figure 8. This snake-like band of discoloration is closer to the glass edge, is parallel to the joint, and is gray. This band is slightly darker than the glass and is very difficult to observe unless viewed at an angle under a strong light. Significant modification of the digital image was needed to view the corrosion band in the photograph. The specular reflectance of the corrosion spots is in dark blue on the photograph with an average specular reflectance of 94.8%. The specular reflectance of the uncorroded area is in light blue with an average specular reflectance of 94.9%. Two possible reasons for such a small difference in reflectance are that the entire sample area (including the “uncorroded” area) was visually degraded, and the “corroded area” was measured inside the snake-like band (rather than along the band).

Figure 8. Digital photograph and specular reflectance of internal snake-like corrosion bands for facet section C2554-27-5 after 21 Mo. of exposure in Arizona

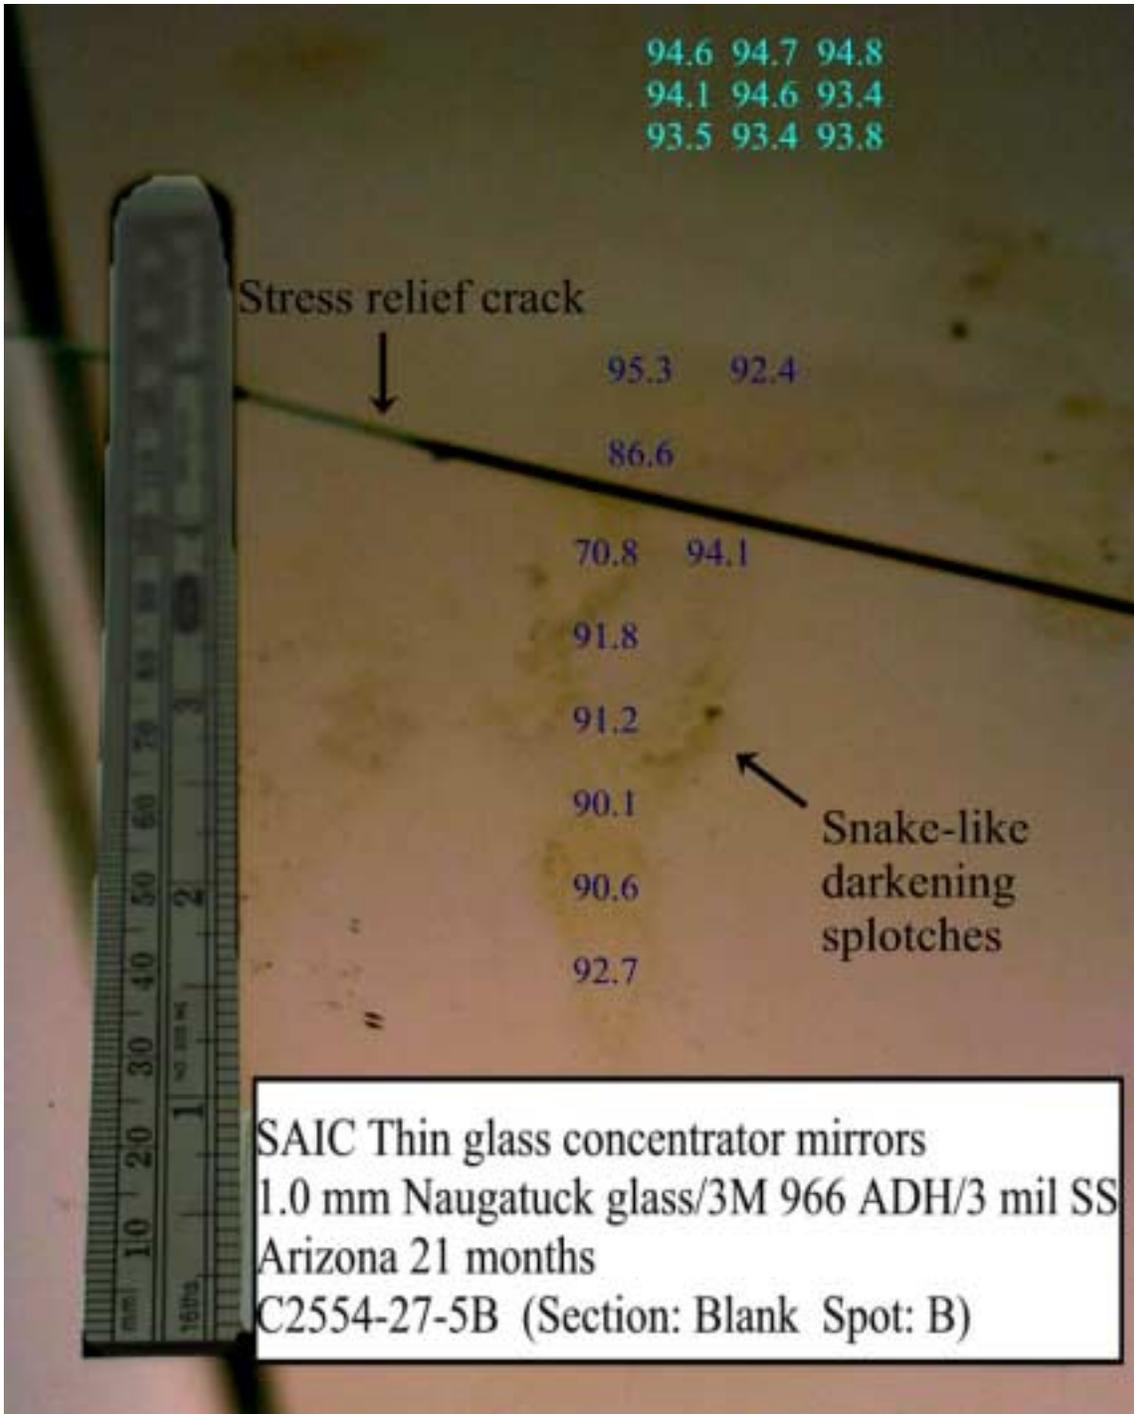
C2554-27-5B; Internal snake-like corrosion band

An area of a snake-like corrosion band that is approximately 20 to 40-mm from the cut-edges, about 200-mm wide and almost as long as the width of facet section C2554-27-5 is shown in Figure 9. The snake-like band of discoloration is internal to the mirrors (i.e., away from the glass edges) and is golden and gray. This band is slightly darker than the glass and is very difficult to observe unless viewed at an angle under a strong light. Considerable modification of the digital image was needed to view the corrosion band in the photograph. The specular reflectance of the corroded area is in dark blue on the photograph with an average specular reflectance of 89.6%. The specular reflectance of the uncorroded area is in light blue with an average specular reflectance of 94.1%.

** The specular reflectance of the uncorroded may be low because this may include some darkening measurements since the corrosion band was so large.

Figure 9. Digital photograph and specular reflectance of snake-like corrosion bands closer to edge joint for facet section C2554-27-5 after 21 Mo. of exposure in Arizona.

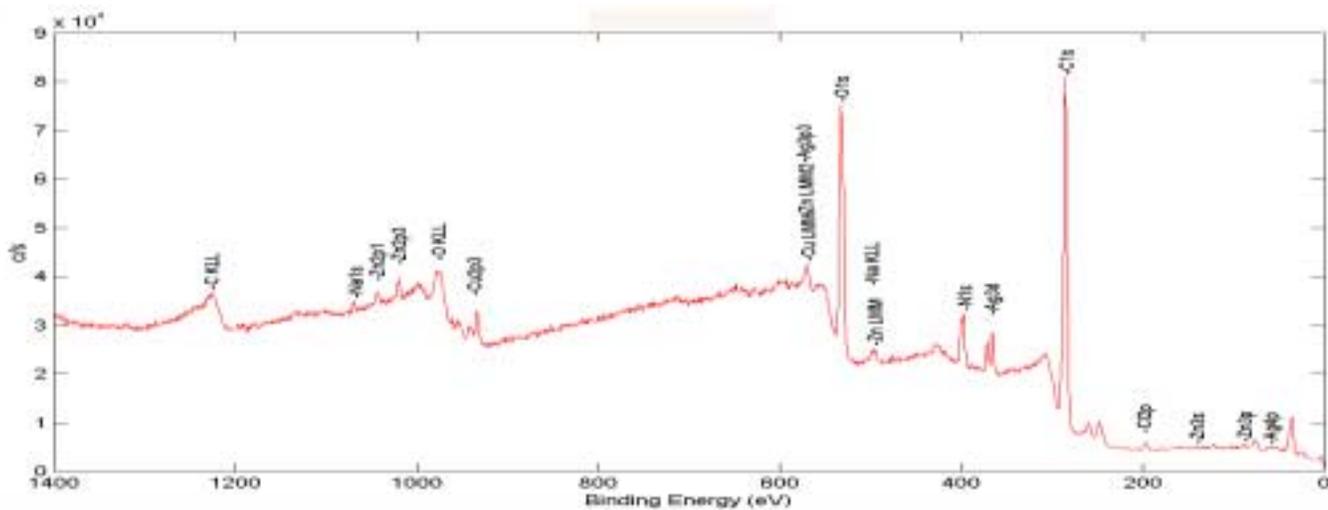
Figure 10 is an XPS survey scan of a corrosion pit. Not surprisingly, the pit consists of oxides of silver and copper. Other elements detected at or near the corrosion pit include carbon, chlorine, nitrogen, oxygen, sodium, and zinc. In order to simplify the complex system of weathered glass, silver, copper, paint, and adhesive, and to determine the origin of the elements detected at the areas of mirror degradation, samples representing the mirrors at different stages of the manufacturing process were procured. Samples of uncoated glass, glass/Ag/Cu, and glass/Ag/Cu/paint were obtained from Naugatuck Glass, the mirror manufacturer. Figure 11 is an XPS survey spectrum of the as-received

Figure 10. XPS survey of corrosion pit on mirror.

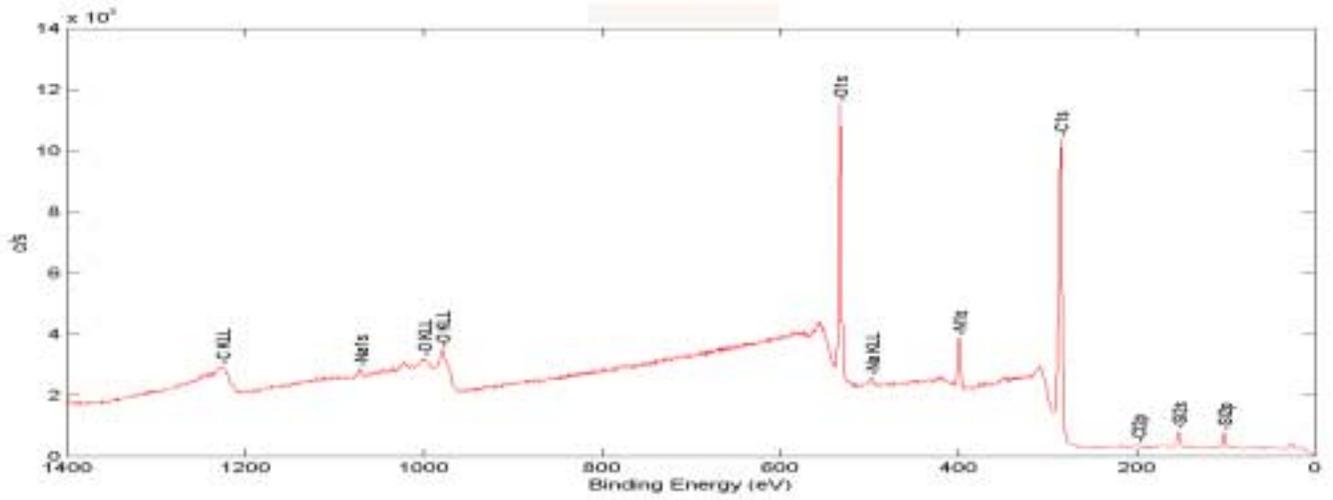
Figure 13 is an XPS spectrum of the paint used to protect the copper layer, and is of an “as-received” sample (not sputtered). Table 3 shows the elemental constituents of the paint and their concentrations as derived from this spectrum.

Figure 13. XPS survey of as-received mirror paint.
