CSP FY01 Milestone Report

“Identify reasons for failure of thin glass mirrors and recommend solutions to industry to avoid further problems in the field”

02/28/01

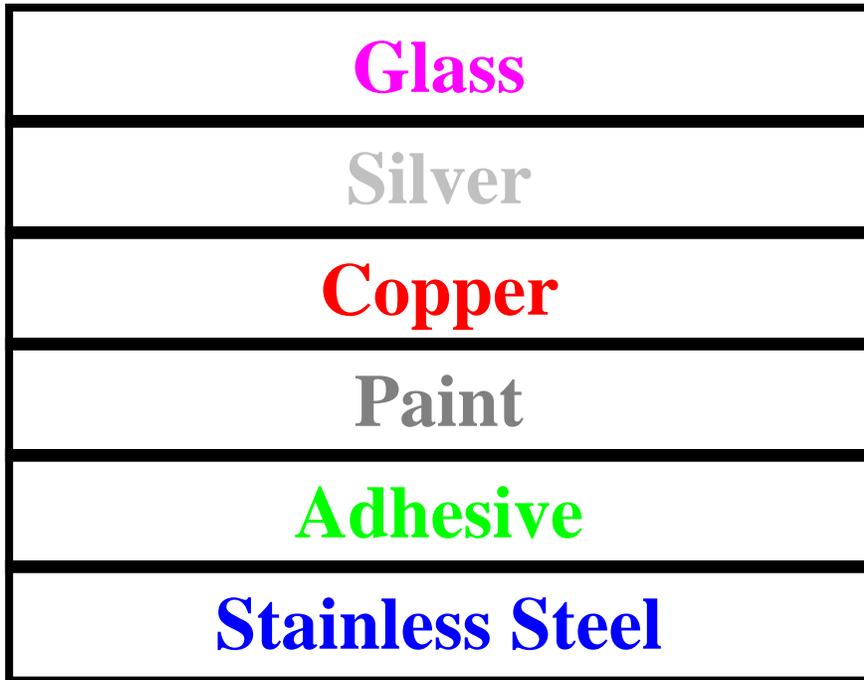
Figure 1. Construction of Mirror Samples

For investigation purposes, SAIC provided a completely dissected facet (3.1-m diameter, cut into 0.6-m x 0.9-m samples) from their Arizona test site. The mirror construction (Figure 1) consists of a thin glass (~1 mm thick) superstrate, a silver reflective layer, a copper protective layer, and a back layer of protective paint. The thin glass mirror material is supplied by Naugatuck Glass. An adhesive (3M 966) is generally used to bond the mirror to a metal substrate (3-mil thick #201 stainless steel foil). No edge protection is used by SAIC.

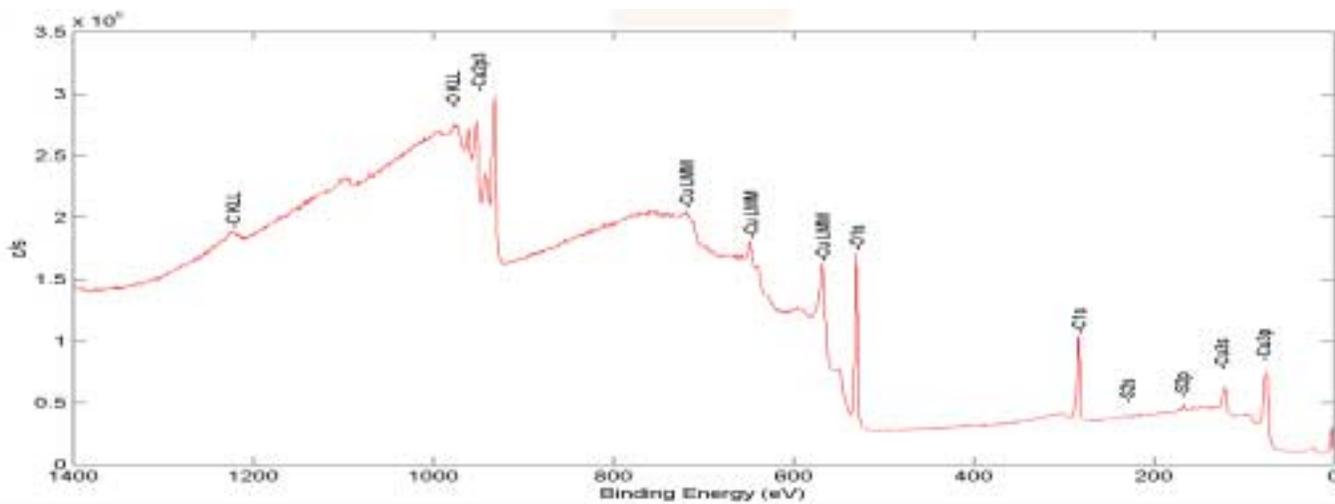
Figure 11. XPS survey of as-received copper layer of mirror.

Figure 10 is an XPS survey scan of a corrosion pit. Not surprisingly, the pit consists of oxides of silver and copper. Other elements detected at or near the corrosion pit include carbon, chlorine, nitrogen, oxygen, sodium, and zinc. In order to simplify the complex system of weathered glass, silver, copper, paint, and adhesive, and to determine the origin of the elements detected at the areas of mirror degradation, samples representing the mirrors at different stages of the manufacturing process were procured. Samples of uncoated glass, glass/Ag/Cu, and glass/Ag/Cu/paint were obtained from Naugatuck Glass, the mirror manufacturer. Figure 11 is an XPS survey spectrum of the as-received

glass/Ag/Cu and is representative of what the manufactured construction consists of immediately before the application of the paint. The spectrum is typical of what one would expect from a pure copper sample that has been exposed to ambient conditions, i.e. a significant amount of carbon and oxygen, and a small amount of sulfur are observed. This same sample was sputtered with 3 keV Ar⁺ to remove the outermost atomic layers. The survey spectrum of the sputtered sample is shown in Figure 12, and essentially is a spectrum of pure copper.
